FINAL TECHNICAL REPORT  
AN INVESTIGATION OF ADHESIVE/ADHEREND  
AND FIBER/MATRIX INTERACTIONS

PART B - SEM/ESCA ANALYSIS OF  
FRACTURE SURFACES

Prepared for  
National Aeronautics and Space Administration

January, 1983

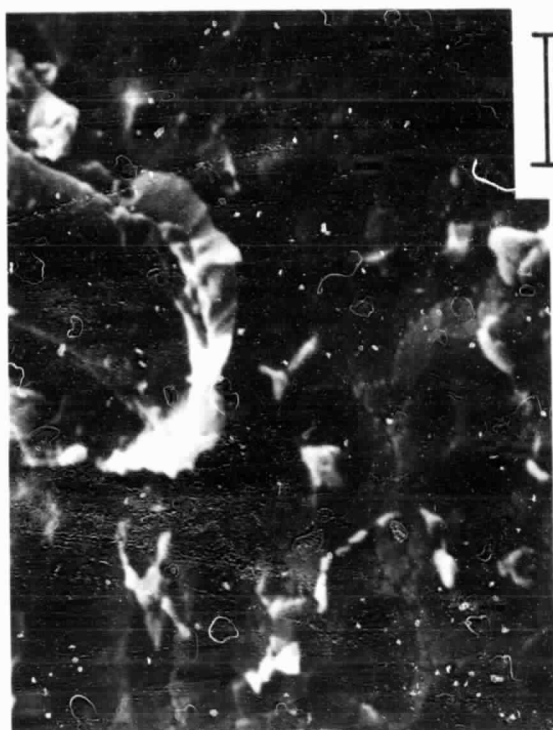
B

[L13-E-1, RT] - Representative SEM photomicrographs of the metal failure surface (MFS), the adhesive failure surface (AFS) and the metal substrate surface (MSS) for this sample are shown in Figure 2. Features characteristic of Ti 6-4 following a phosphate/fluoride (Picatinny) etch (12) are seen in Figures 2A and 2B for the metal failure surface (MFS). The small white "particles" seen on the surface are in fact the  $\beta$  phase of this alloy.

Figure 2. SEM photomicrographs of the metal failure surface at 1000X (A); at 5000X (B); of the adhesive failure surface at 5000X (C); of the metal substrate surface at 550X (D) for Sample No. [L13-E-1, RT].

- (A) METAL FAILURE SURFACE AT 1000X
- (B) METAL FAILURE SURFACE AT 5000X
- (C) ADHESIVE FAILURE SURFACE AT 5000X
- (D) METAL SUBSTRATE SURFACE AT 550X

The imprint of the adherend on the adhesive failure surface (AFS) is clearly seen in the SEM photomicrograph in Figure 2C on comparison with Fig. 2B. In addition, cracks and/or voids are noted on the adhesive failure surface. The nodule in the center of Fig. 2C is an alumina particle based on EDAX analysis. Alumina is a component of the L13 adhesive.

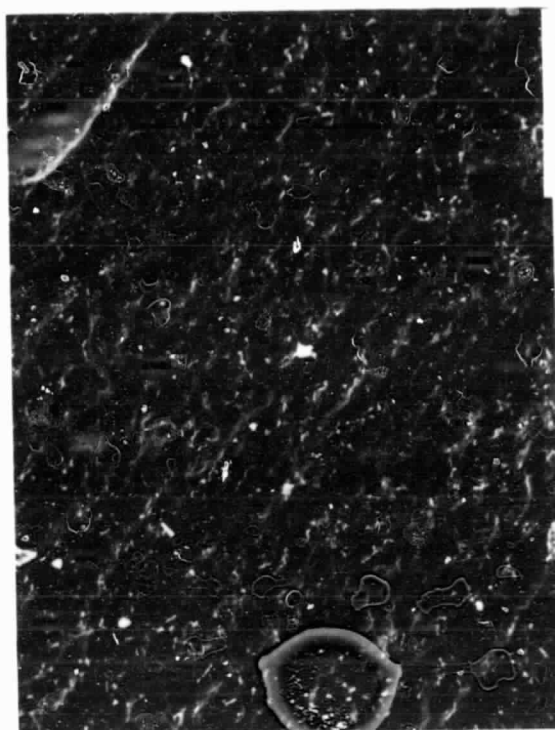
D

The SEM photomicrograph of the metal substrate surface (MSS) is shown in Figure 2D. Similar features are seen on comparing Fig. 2D with Fig. 2A. Thus, minimal adhesive remains on the metal substrate surface (MSS).

The metal substrate surface (MSS) gives again an oxygen doublet showing that both adhesive and adherend surface oxide are on this sample. It is emphasized that this level of atomic definition is possible with the ESCA technique but not with the SEM technique.

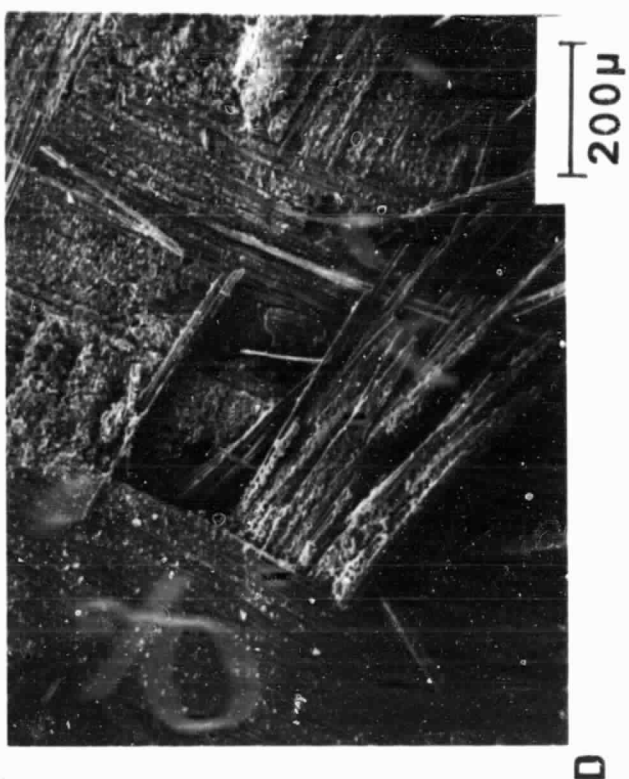
D

Figure 3. SEM photomicrographs of the adhesive failure surface at 50X (A) for Sample No. [L13-E-8, RT]; of the metal failure surface at 500X (B) for Sample No. [L13-G-3, RT]; of the adhesive failure surface at 100X (C) for Sample No. [L13-G-4, 450]; of the adhesive failure surface at 100X (D) for Sample No. [L13MI-G-4, 450].

- (A) ADHESIVE FAILURE SURFACE AT 50X FOR SAMPLE NO. [L13-E-8, RT]
- (B) METAL FAILURE SURFACE AT 500X FOR SAMPLE NO. [L13-G-3, RT]
- (C) ADHESIVE FAILURE SURFACE AT 100X FOR SAMPLE NO. [L13-G-4, 450]
- (D) ADHESIVE FAILURE SURFACE AT 100X FOR SAMPLE NO. [L13MI-G-4, 450]

-Significantly a considerable amount of fractured scrim cloth was noted on the adhesive failure side of this sample (see Fig. 3D) as in the preceding one. This suggests that there is a difference between the L13 and L13MI adhesive systems on a Turco pretreated Ti 6-4 surfaces independent of temperature. This was not the case for a phosphate/fluoride pretreated Ti 6-4 surface. Mason, Siriwardane and Wightman (19) have shown that an acidic Ti 6-4 surface results from a phosphate/fluoride pretreatment whereas a basic Ti 6-4 surface results from a Turco pretreatment.

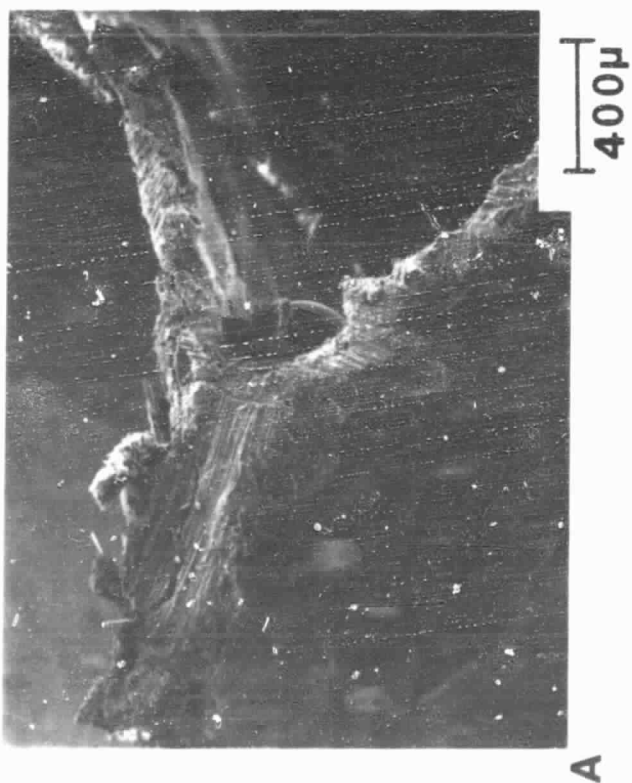
2. Sample No. 3-26 - This sample yielded 3 surfaces for analysis. The honeycomb structure was examined by SEM and showed fibers well wet by the matrix as can be noted in Figures 5A and 5B. No ESCA analysis was made on this surface because of sample configuration. The surface of the adhesive next to the honeycomb structure and next to the composite panel were analyzed. The SEM photomicrographs were quite different. For example, the honeycomb side (see Fig. 5C) showed no fibers whereas fibers were seen on the composite sides (see Fig. 5D). Again carbon, fluorine, nitrogen and oxygen ESCA

Figure 5. SEM photomicrographs at 50X (A) at 500X (B) of the honeycomb structure from FWT Sample No. 3-26; at 500X (C) for the adhesive adjacent to the honeycomb structure; at 500X (D) for the adhesive adjacent to the composite panel.

- (A) HONEYCOMB STRUCTURE AT 50X**
- (B) HONEYCOMB STRUCTURE AT 500X**
- (C) ADHESIVE ADJACENT TO HONEYCOMB STRUCTURE AT 500X**
- (D) ADHESIVE ADJACENT TO COMPOSITE PANEL AT 500X**
